## Forest View Lanes

## Temperance, MI

## 20 Lanes – Remove old Murrey Lanes and old Accuscore+ Scoring.

Install New QAMF SPL Lanes with Approach, Pindecks, Flatgutters, and Transition Blocks. Install BES-X Scoring with Touchscreens, MMS System, and QPAD.

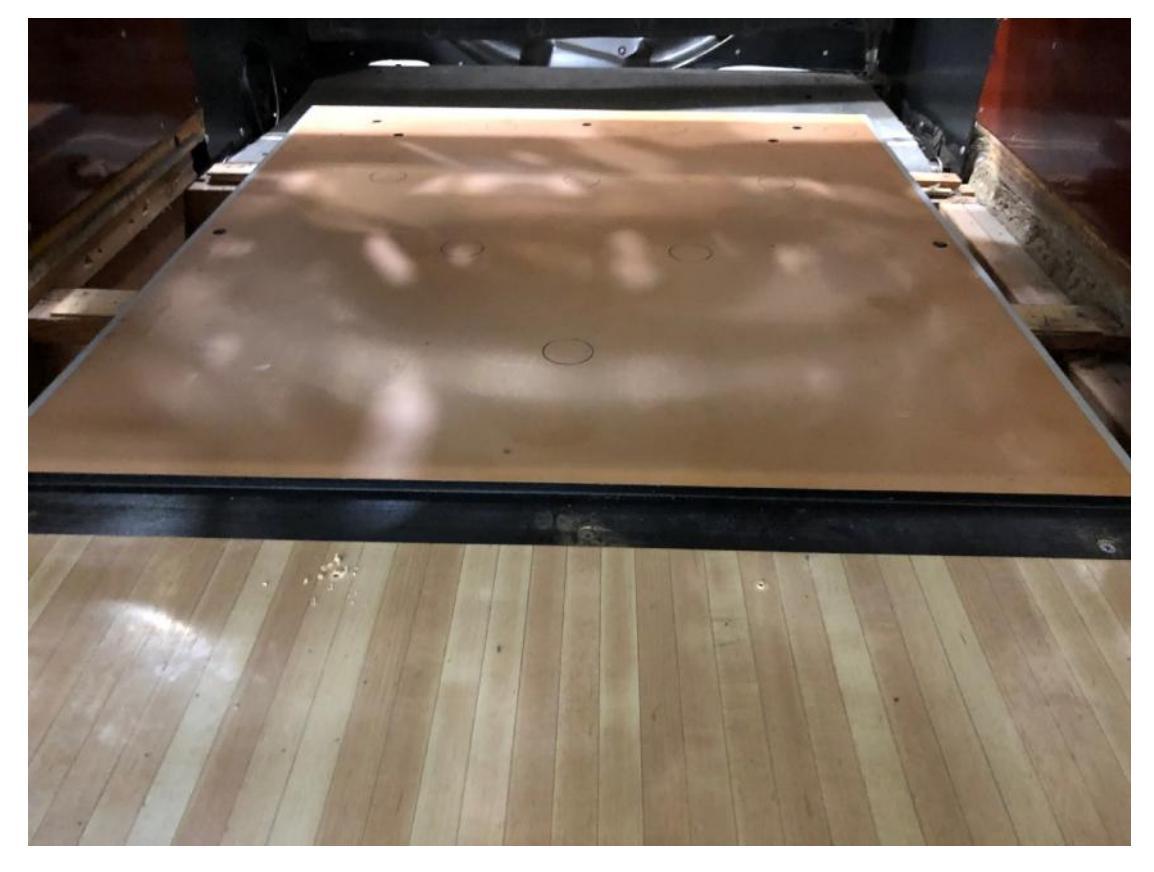
We measured the lanes from the lane-side of the foul line, to the center of the headpin on lanes 11-20. They were all more than  $\frac{1}{2}$ " too long (USBC Tolerance is 60' +/-  $\frac{1}{2}$ "), which makes them illegal. I can't believe that these lanes were sanctioned. We will adjust for this when we install the new lanes and pindecks, to make them 60'. We removed all of the old flatgutters, the old maple transition blocks, and the old pindecks. We trashed the flatgutters and transition blocks, but saved the pindecks for the customer. It was a disaster beneath the old pindecks. The pindeck support lumber was split and worthless.

We removed all of this support lumber and installed new.

Then we installed the new pindecks in the center of USBC tolerances.

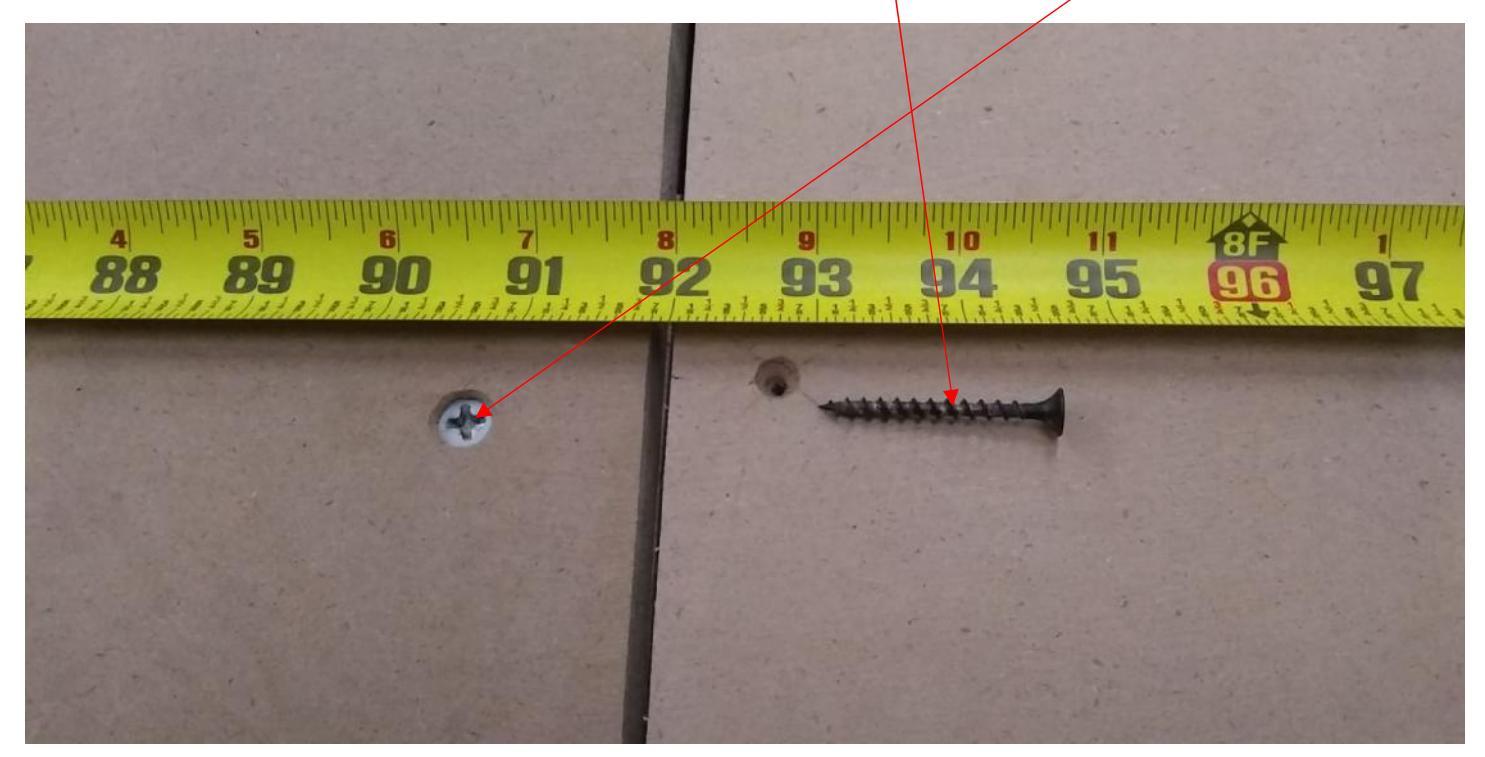
The existing Underlayment was secured with  $#6 \ge 1\frac{1}{2}$ " Drywall Screws beyond 7' from the foul line! Unbelievable! Many were broken. The first 7' were secured with a slightly larger screw.

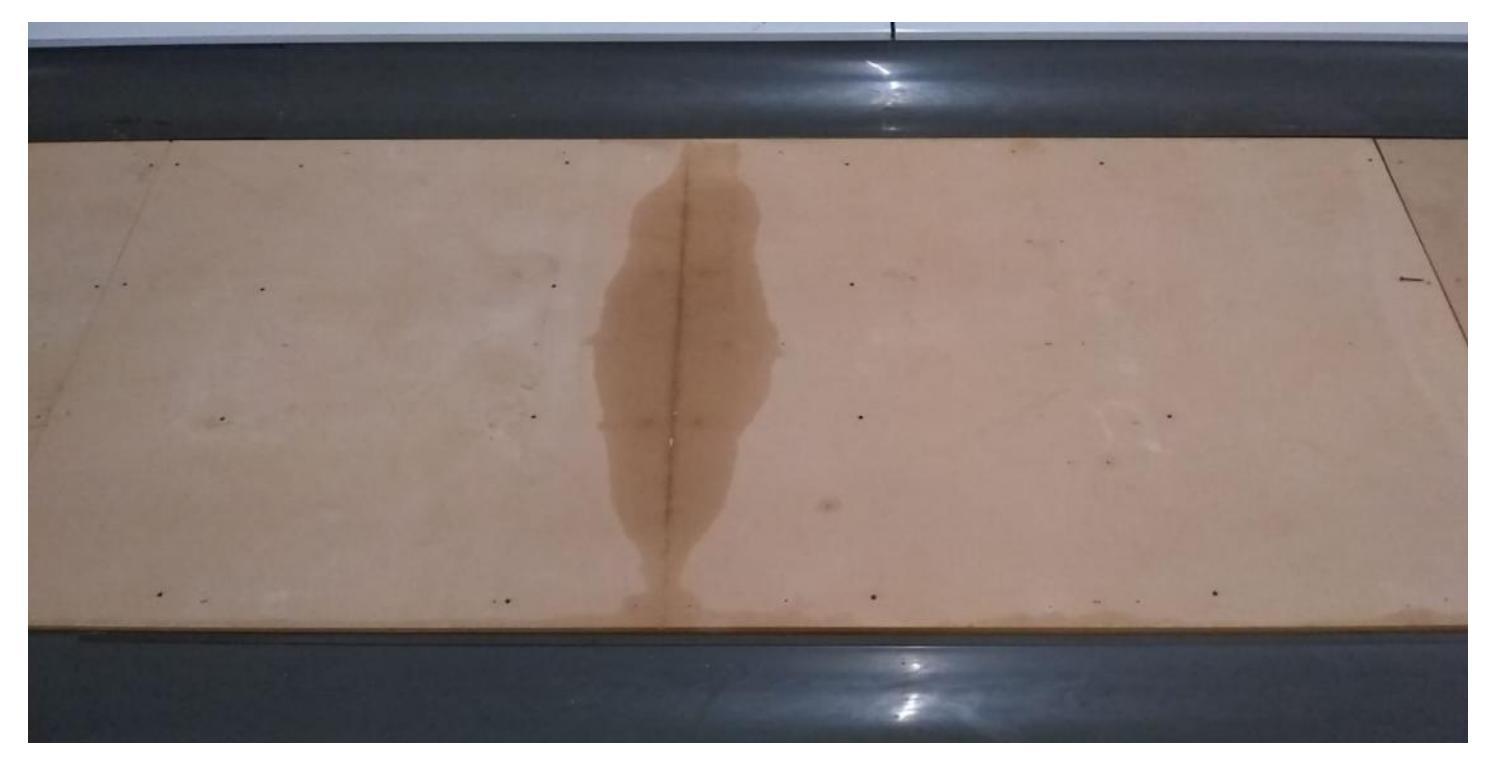
Many of the Lane Panel Joints were not sealed, allowing oil and lane cleaner to penetrate to the MDF Underlayment.

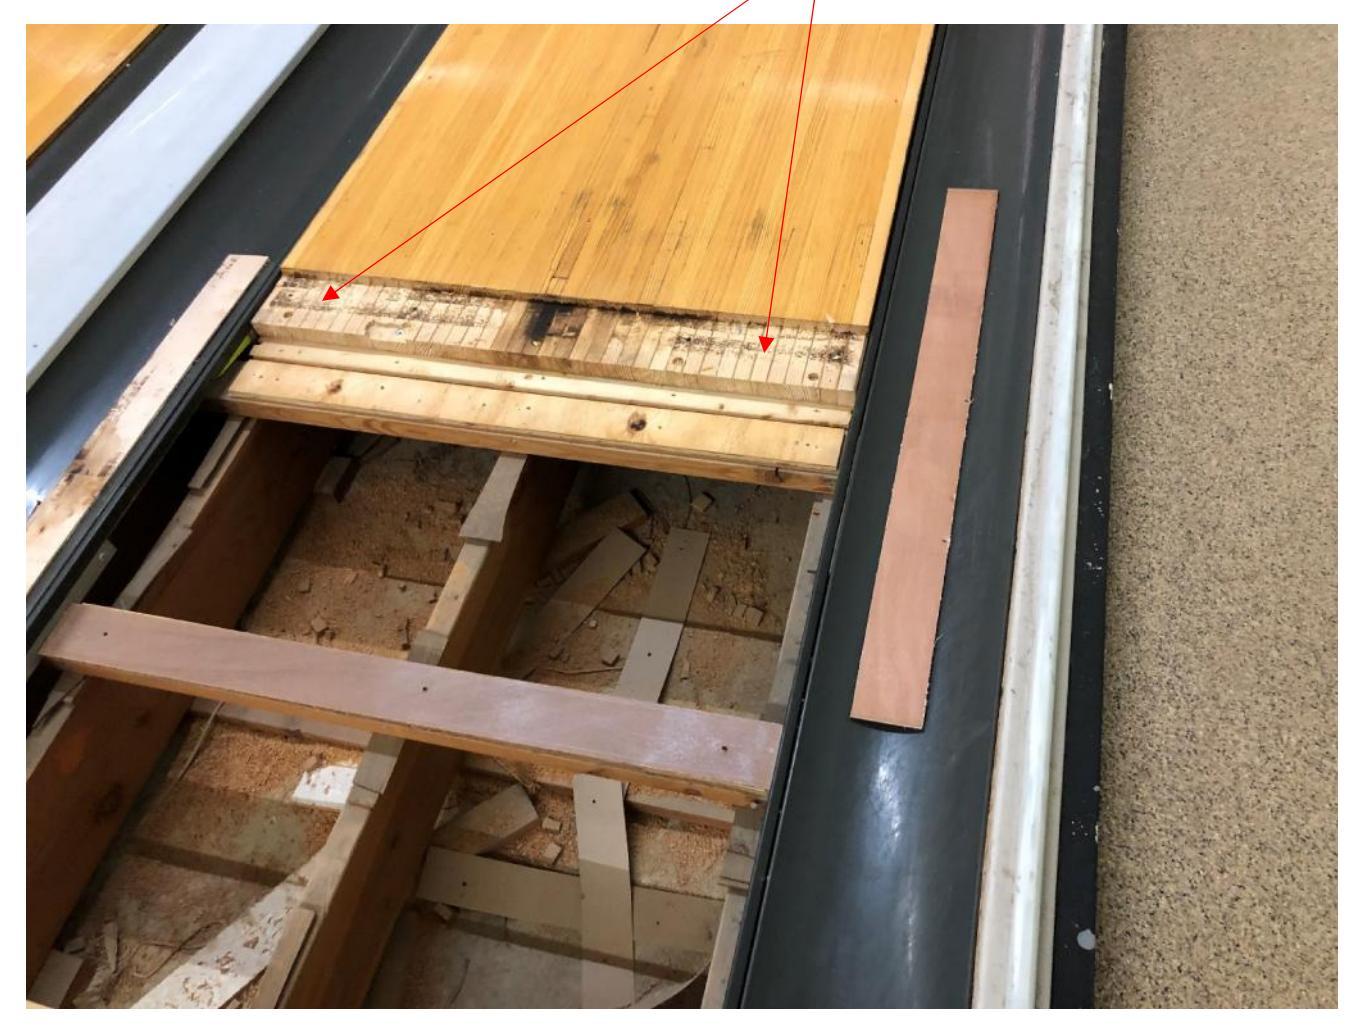
The removal also revealed, that the previous installers cut a 5" Rabbet (cut-out notch) where the MDF met the old Pine Wood Lane. Reason unknown.

The former installers also made their continuous approach cut <u>BETWEEN LEVELERS</u> (you should always make an approach cut on the center of a leveler, so you will have support for both the old maple approach side AND the new LSL or MDF side. All of the old approach <u>is dangling</u> 10" from the nearest rearward leveler. Shocking. There is NO SUPPORT under the Maple Approach Cut. They should have cut HERE.

We will have to add support lumber across the 2 x 10 Stringers, so this approach edge is not dangling - with no support beneath it. We began to remove all lumber and shim materials from the original levelers.

We finished Shimming the bare levelers level. We fixed the huge problem left by the previous installers, of having NO SUPPORT under the approach cut that the previous installers made. Instead of making the approach cut in the center of a leveler, they cut the approach between levelers, leaving the approach cut without support beneath it, as pictured on Day 3 above. We screwed 2 x 4" material directly to the Stringers (the 2 x 10" support lumber standing on edge, which supports the entire lane installation), centered under this dangling approach cut end. We left the region over the Double Division Ball Return Track unencumbered, since a returning ball would not fit comfortably under our new, (lower) additional support lumber's elevation. We then tightly Stuff-Shimmed the gap between the new 2 x 4" leveler, and the dangling approach end cut (this shim pack).

We then Top-Screwed the Dangling Approach End, so that it is solidly supported by the new leveler and shimpack we added.

This totally cured the previous installer's blunder, of cutting the approach IN BETWEEN levelers instead of on the center of a leveler. There is a dangling approach edge no longer. We then drew two strings. One for ensuring the proper elevation for shimpacks to be installed on each of the 18 levelers between the Old Pine Wood Lane and the Maple Approach (that was formerly dangling). The other, to mark the exact location of the 10-side edge of the new LSL we will be installing. We had marked the Zero Board and the #1 Board, with an X on the Maple Approach yesterday. The strings are tight as a piano wire (almost).

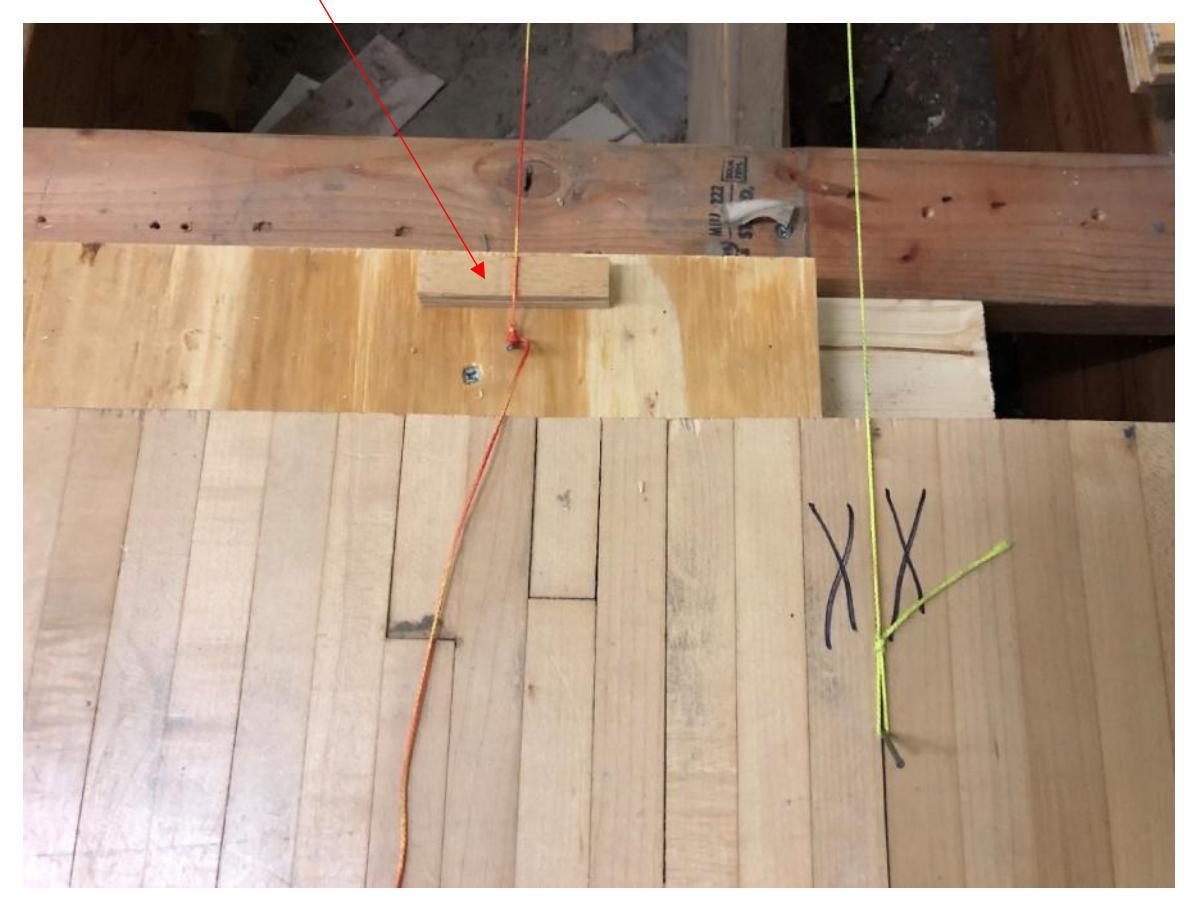
We placed a piece of  $\frac{1}{2}$ " shim material under the Leveler Elevation String on both ends.

Now, using another piece of  $\frac{1}{2}$ " shim material as a gauge-block, we add shim material to each of the 18 exposed levelers, until the shimpack is exactly within this  $\frac{1}{2}$ " gauge-block's thickness, of our stretched elevation string. This ensures flat elevation of the LSL. The average thickness of the Shimpacks needed to get to the desired elevation on each of the 18 exposed levelers, was 1  $\frac{3}{4}$ ". This is an abnormally large amount. We would certainly run out of the usually adequate amount of shim material provided by QAMF to do the job,

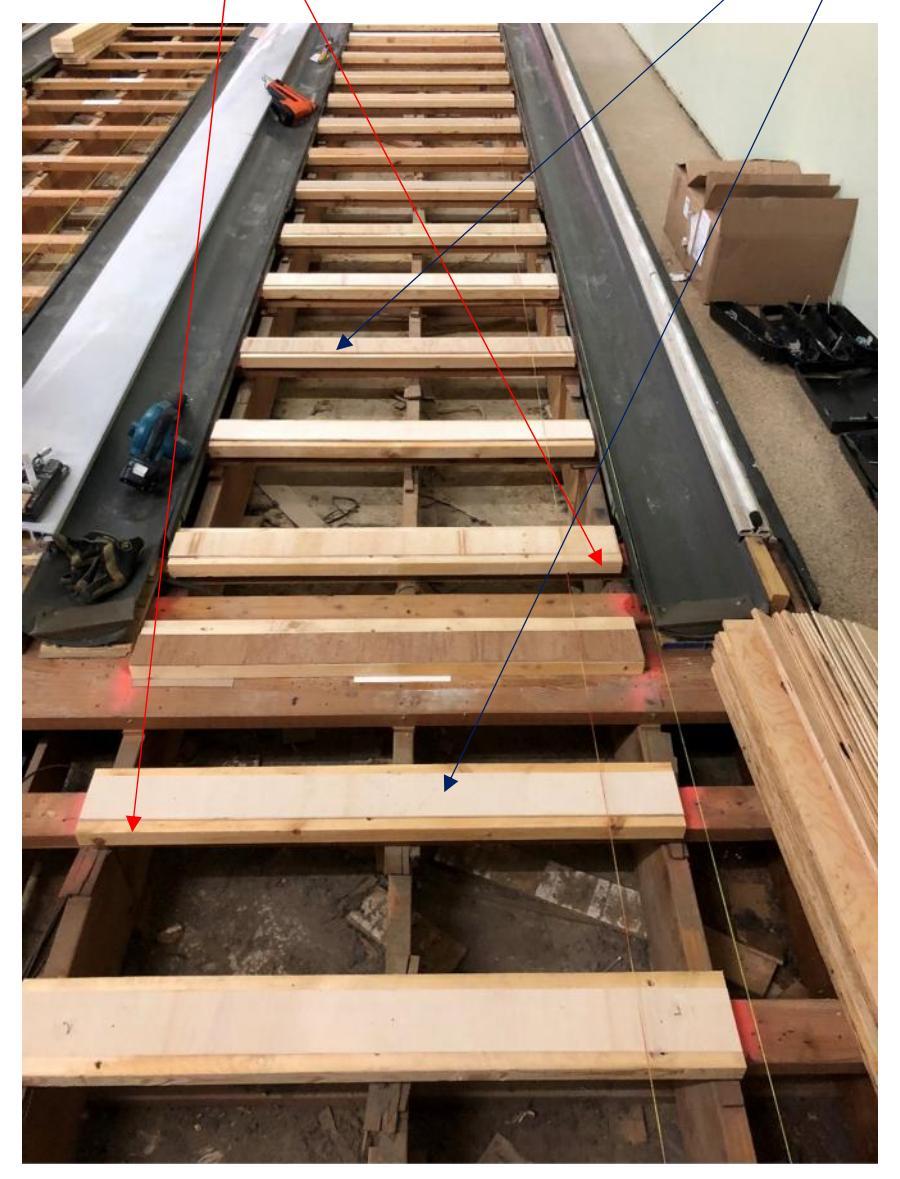
We cut up this 2 x 6" lumber into 41" pieces, to use as leveler shim material, and added the additional  $\frac{1}{4}$ " or so, guaranteeing that we would have plenty of shim material to do the job easily. We shimmed all 18 levelers on all 10 lanes to the proper elevation to be ready for LSL installation.

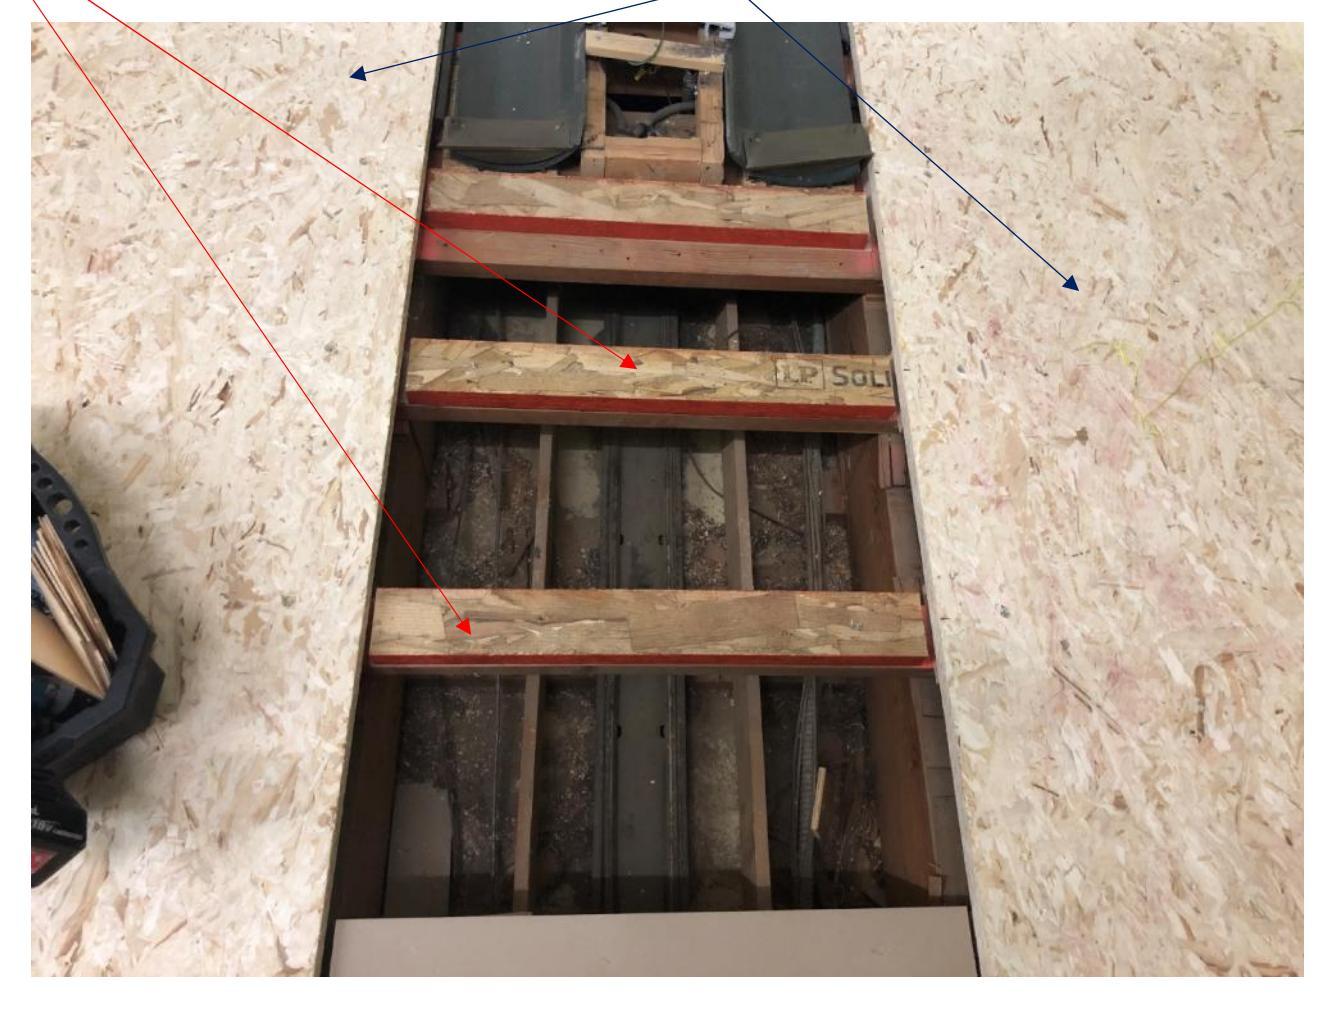
We shimmed for all fill-LSL that goes between the Lane Sheets.

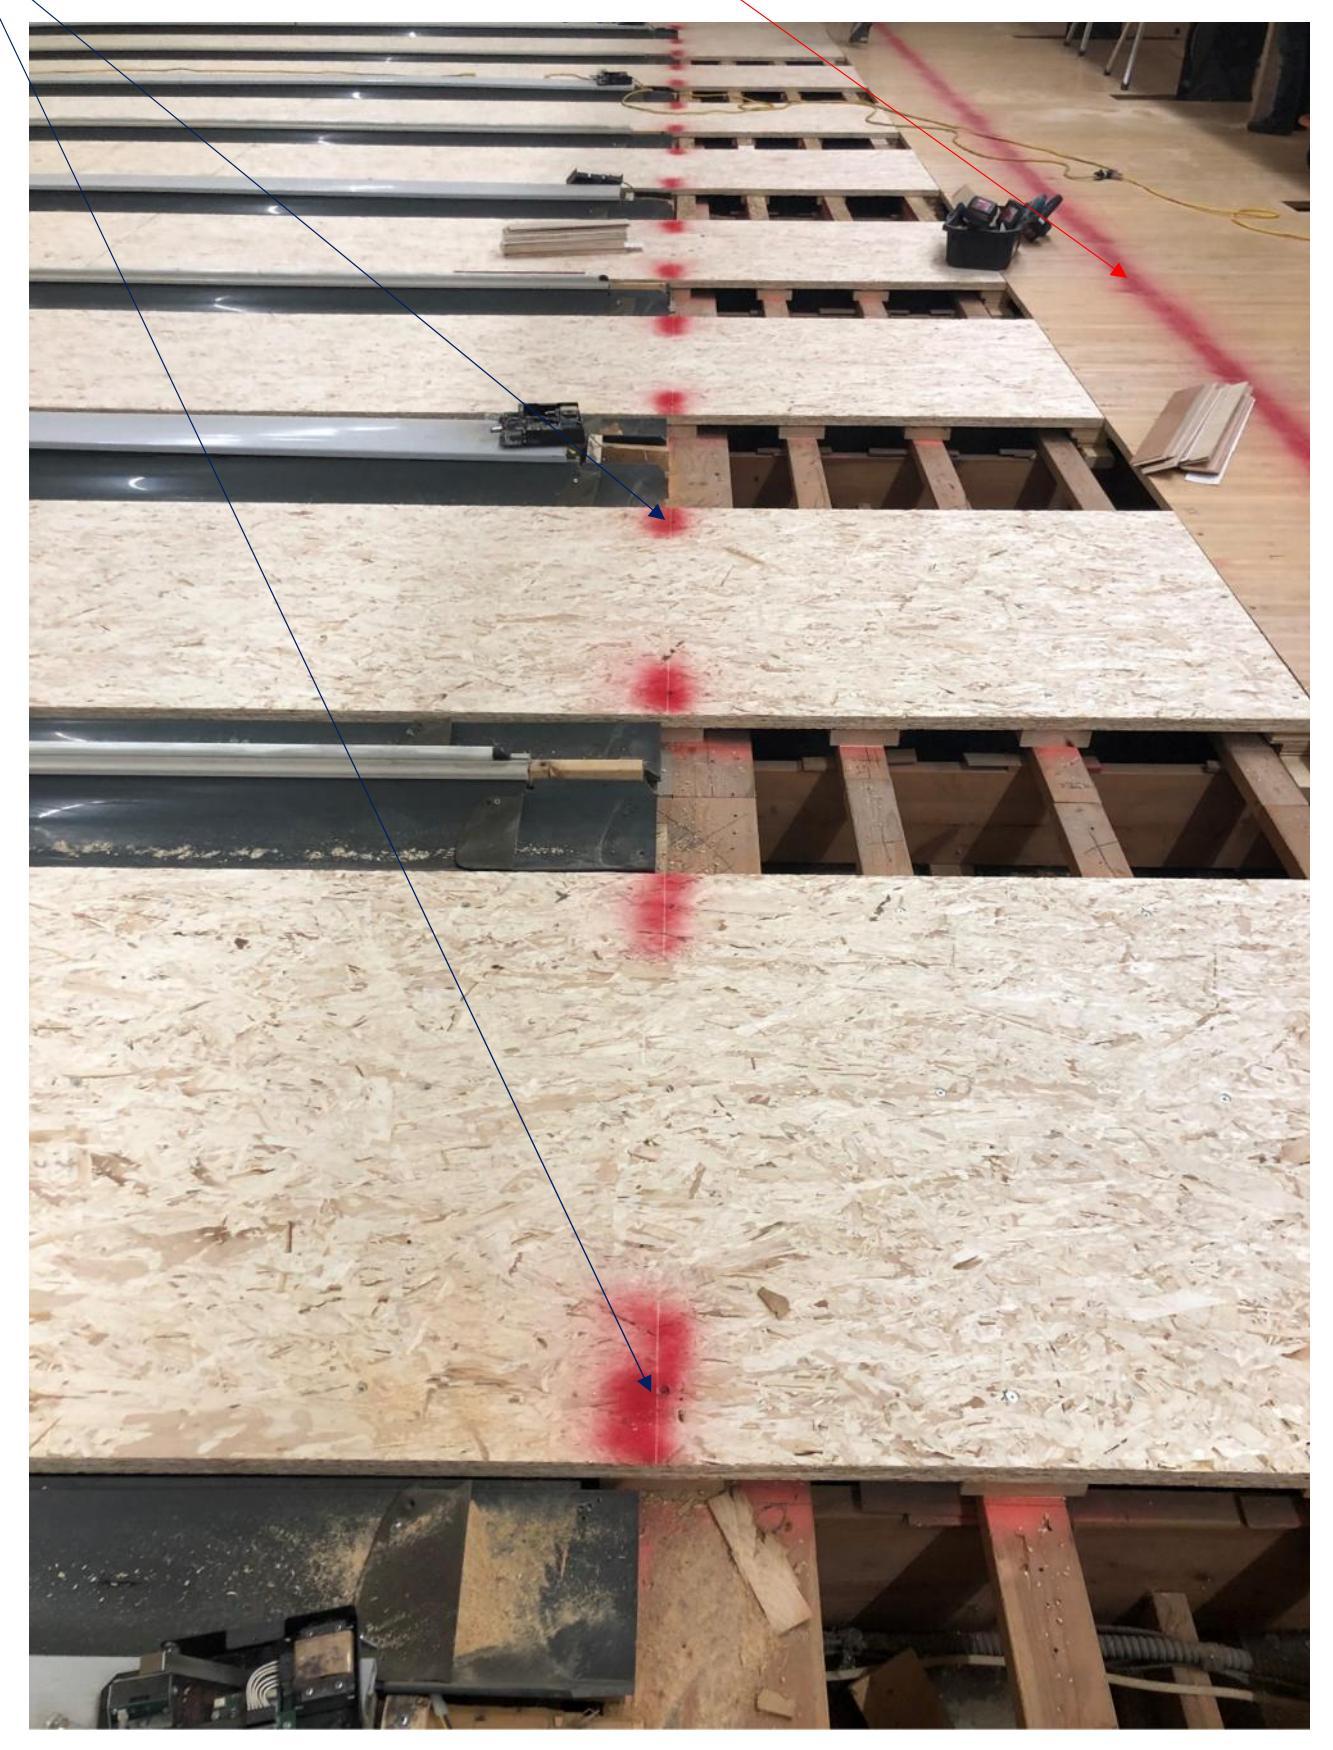
We measured back exactly 6' from our reference line, painted continuously on the maple approach, to relocate the exact position of the joint between the new SPL Lane Panels and the new SPL Approach Panels. We painted this approach/lane panel joint location on each lane.

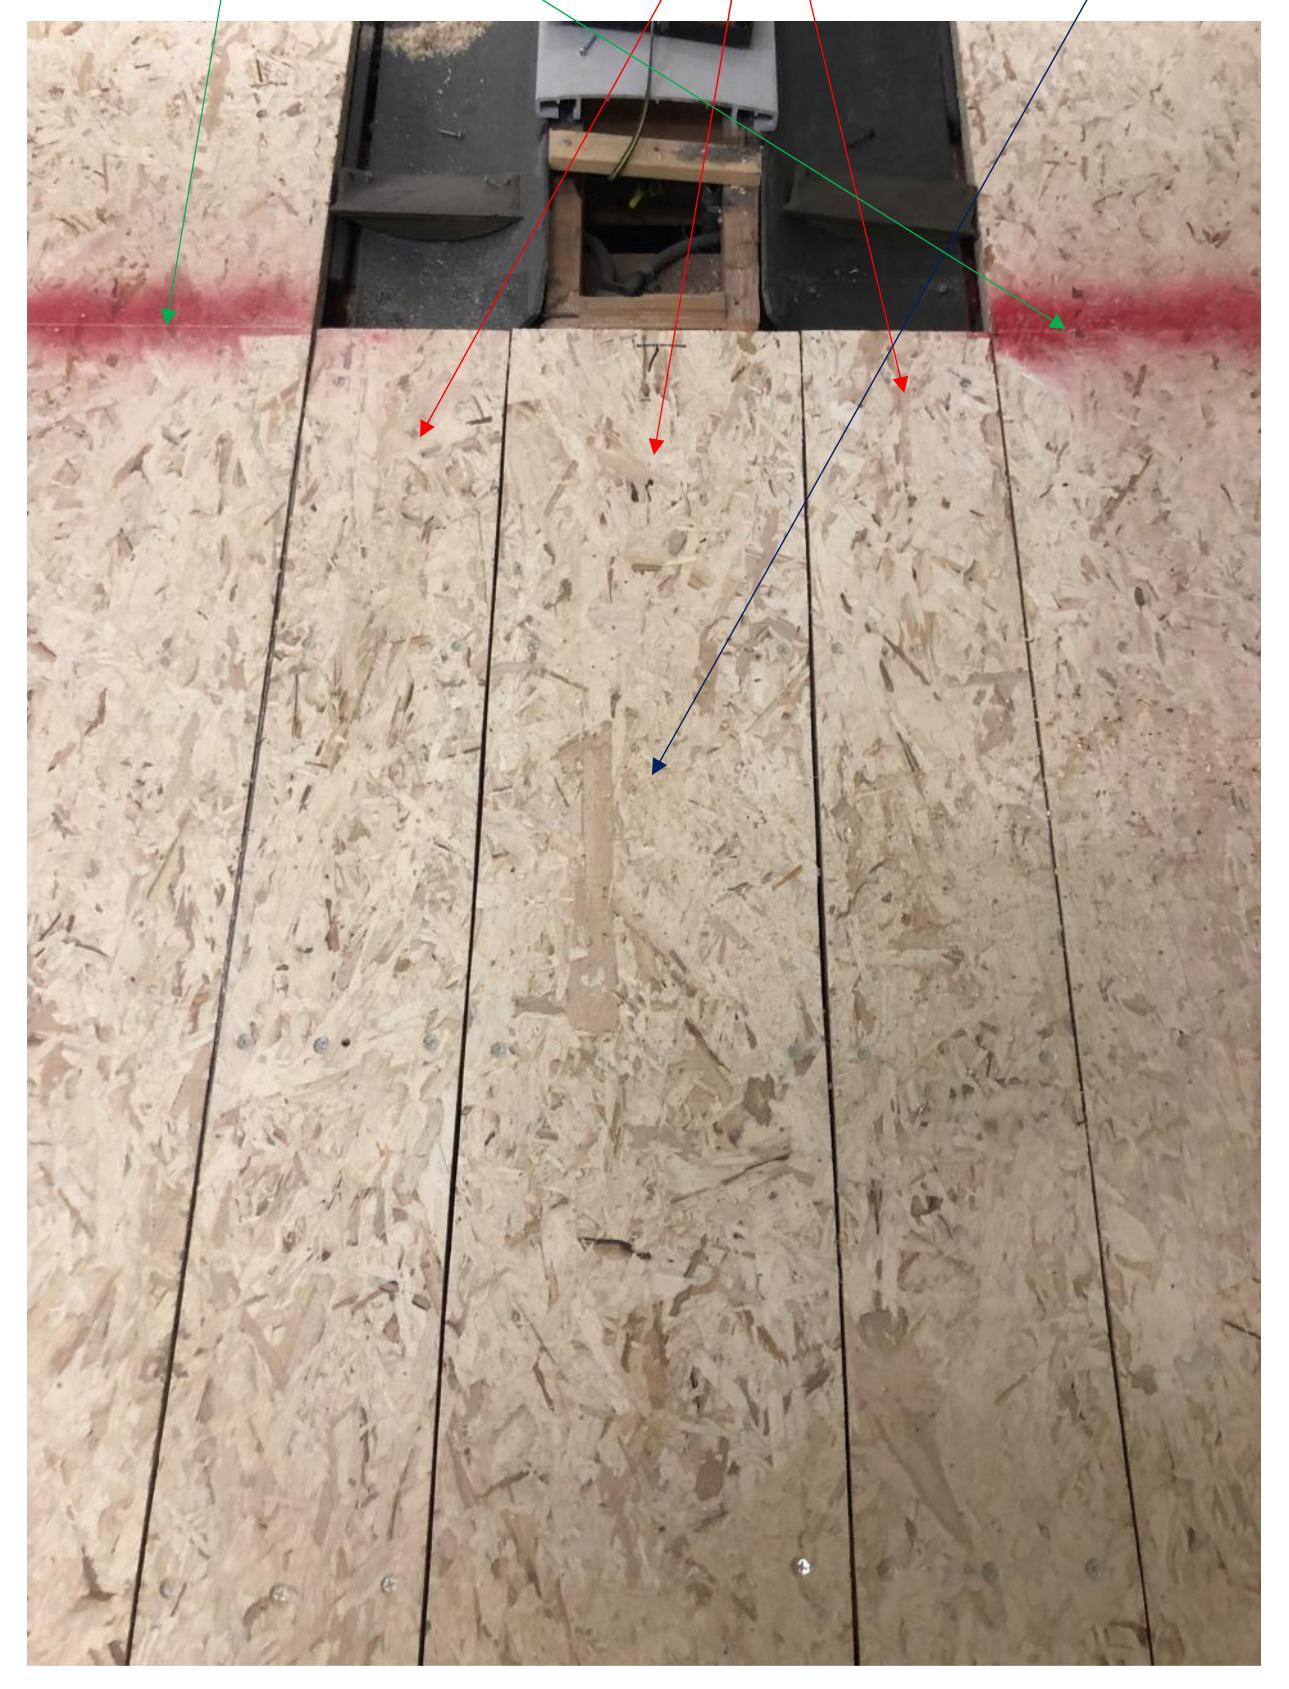
We use this painted red line to position the LSL Fill Panels slightly behind this Joint Locator. We cut-to-fit and installed all LSL Fill Panels. We cut the Double Fills into three pieces, with a 12" piece in the center, so that the Center could more easily access their Underlane Track beneath the approach, without removing any 5' x 12' Approach Panels. The 12" center Keyway we installed, will allow access to the underlane track, simply by removing the eventual SPL Double Division Fill Panel. No need to remove any of the large Approach Panels.

(I can't believe that the previous installers didn't install a Keyway in their Double Division Approach Fills).

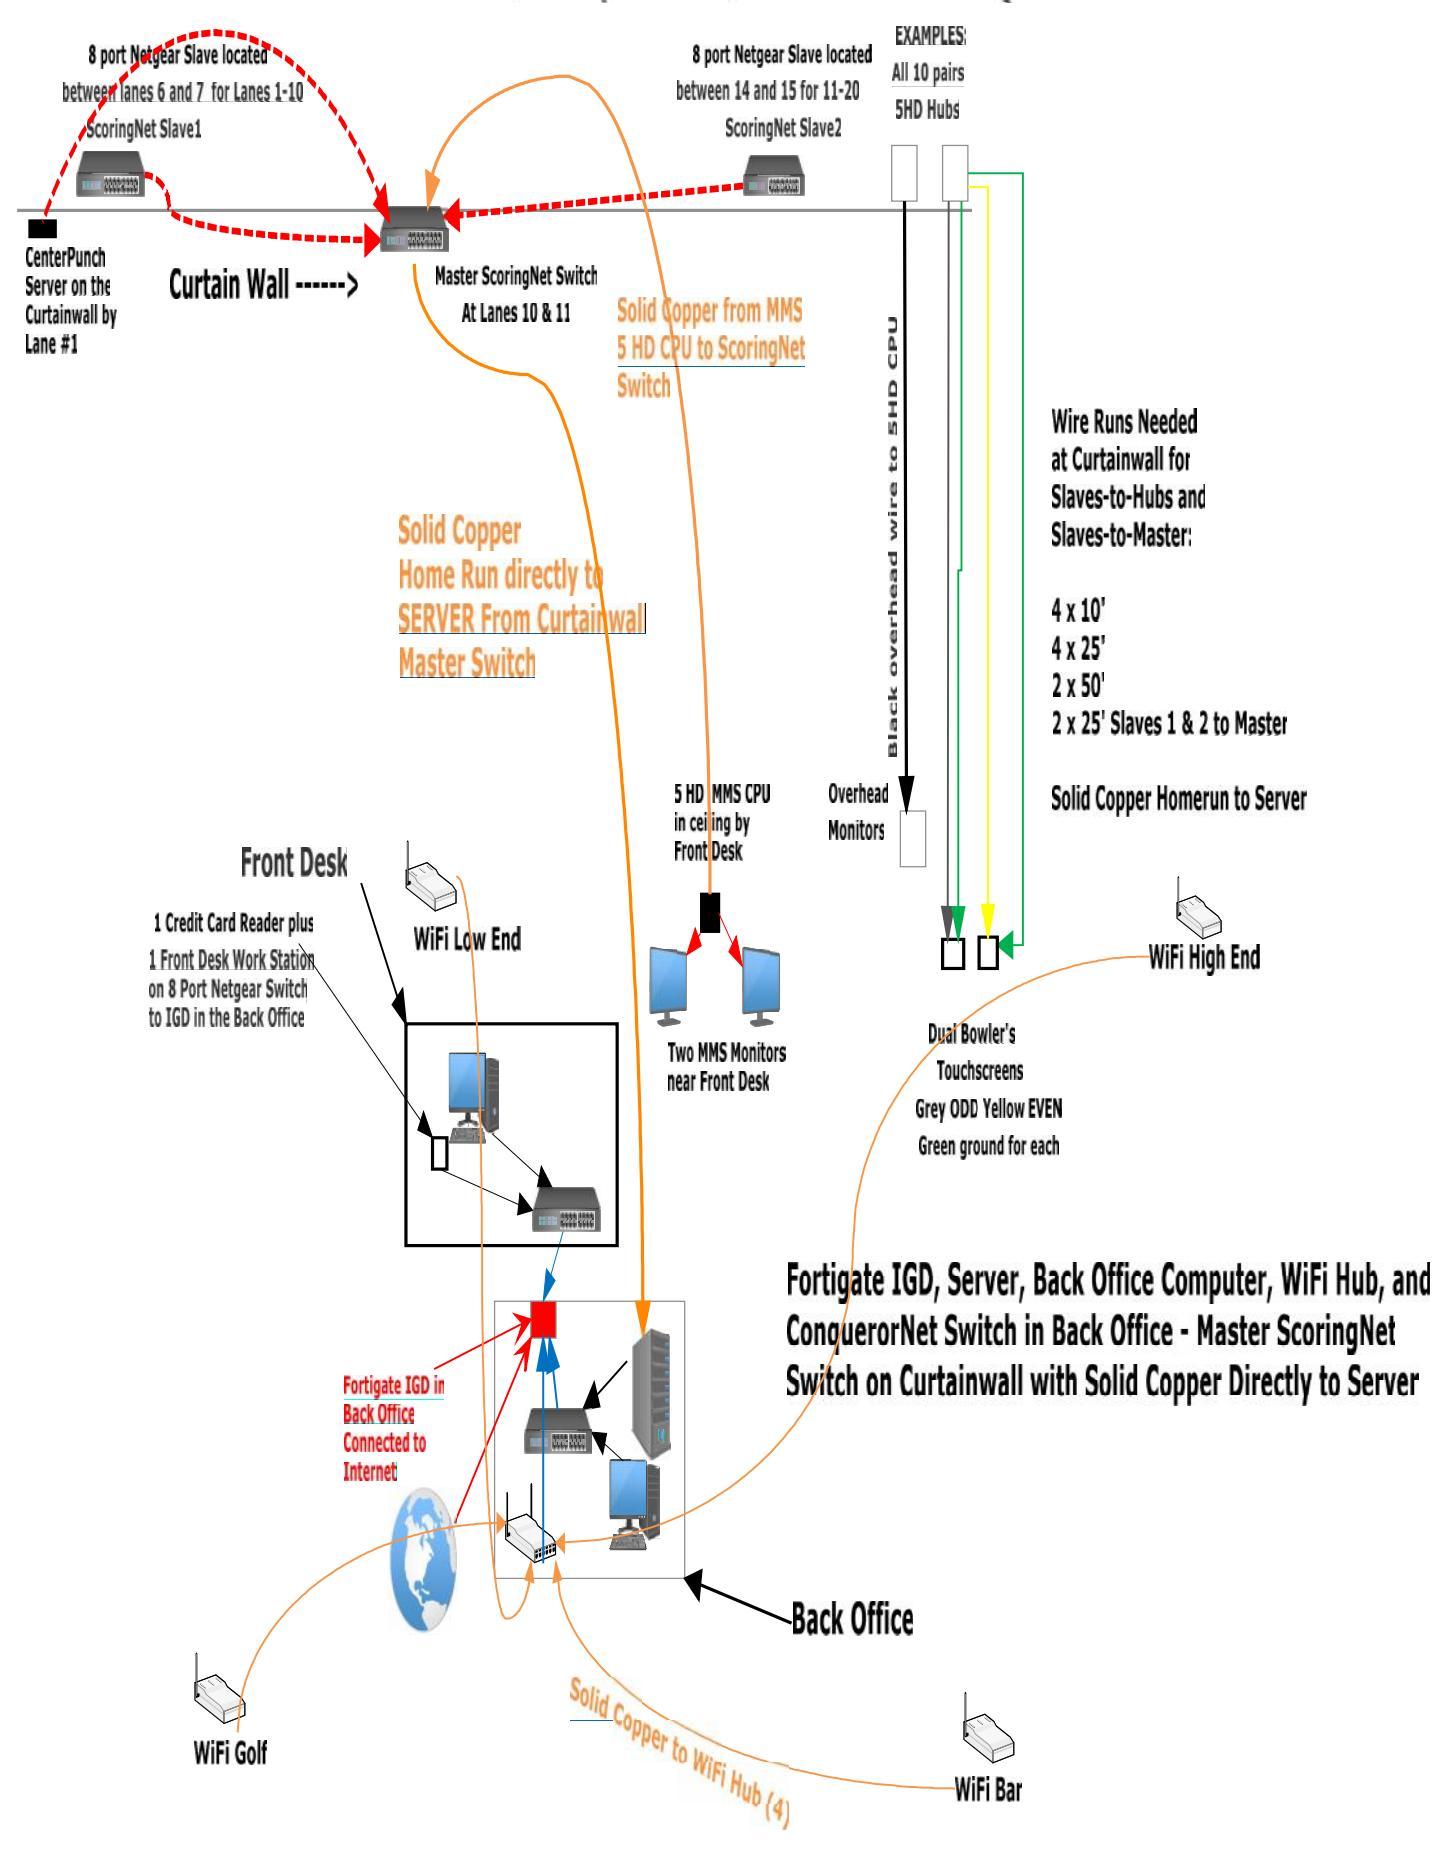
## Forest View Lanes, Temperance, MI Network Diagram

Here is the Network Diagram for Forest View (without WiFi Qpad included yet):

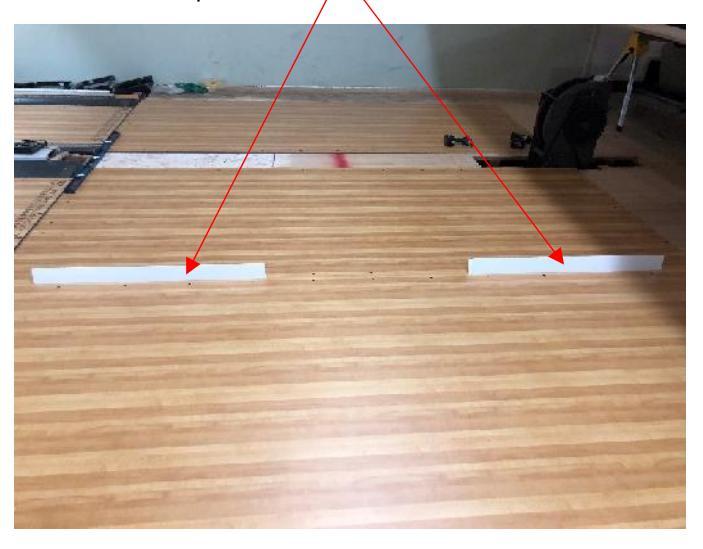
We tacked the Approach Panels in place, to produce a good Board Pattern across the Approach/Lane Joint. Most the original lanes here were over 21" apart across the Singles, so we had to "cheat" the board pattern slightly on either side of each single. But, it ended up very good. This is very common in older original installs of wood lanes. Also, the old lanes were well out of square (to the lane 20 side from front-to-back). This will cause a very slight "stair-step" in the Double Division Fill Panels, where the Fills blend with the Approach Panels. It is very minor. We gapped the Large Approach Panels with .030" of shim material in this hot-and-cold climate region of the country. Two .015" Paper Shims, here.

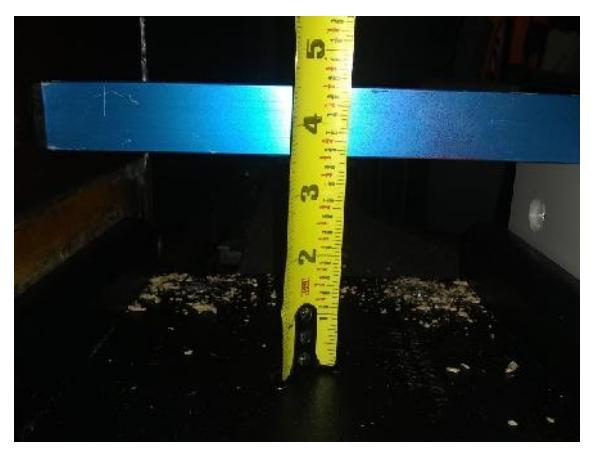
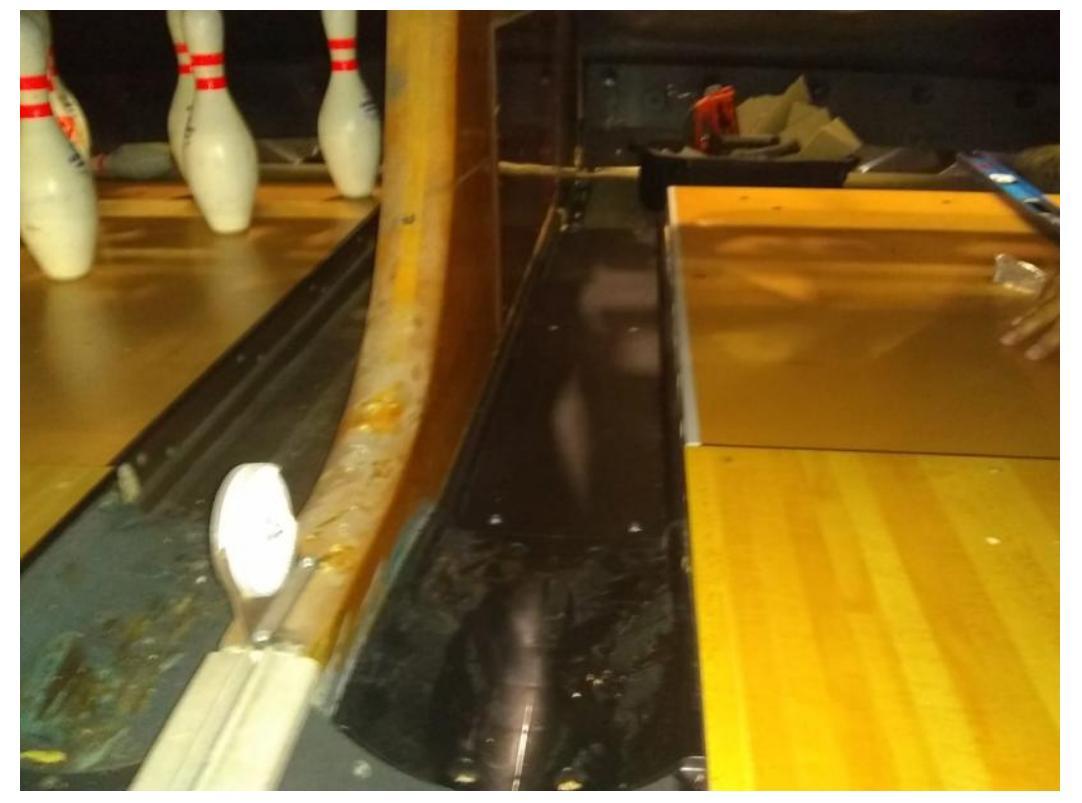
We got about half of Flatgutters and Transition Blocks installed. We set them all in the center of the USBC specification of 3.5'' + - 1/8'' – measuring this depth at the 7-10 line.
